# Precipitator Solves Dryer Problem

Plum Creek, Columbia Falls, MT

Chief Engineer - PPC Industries, Longview, TX

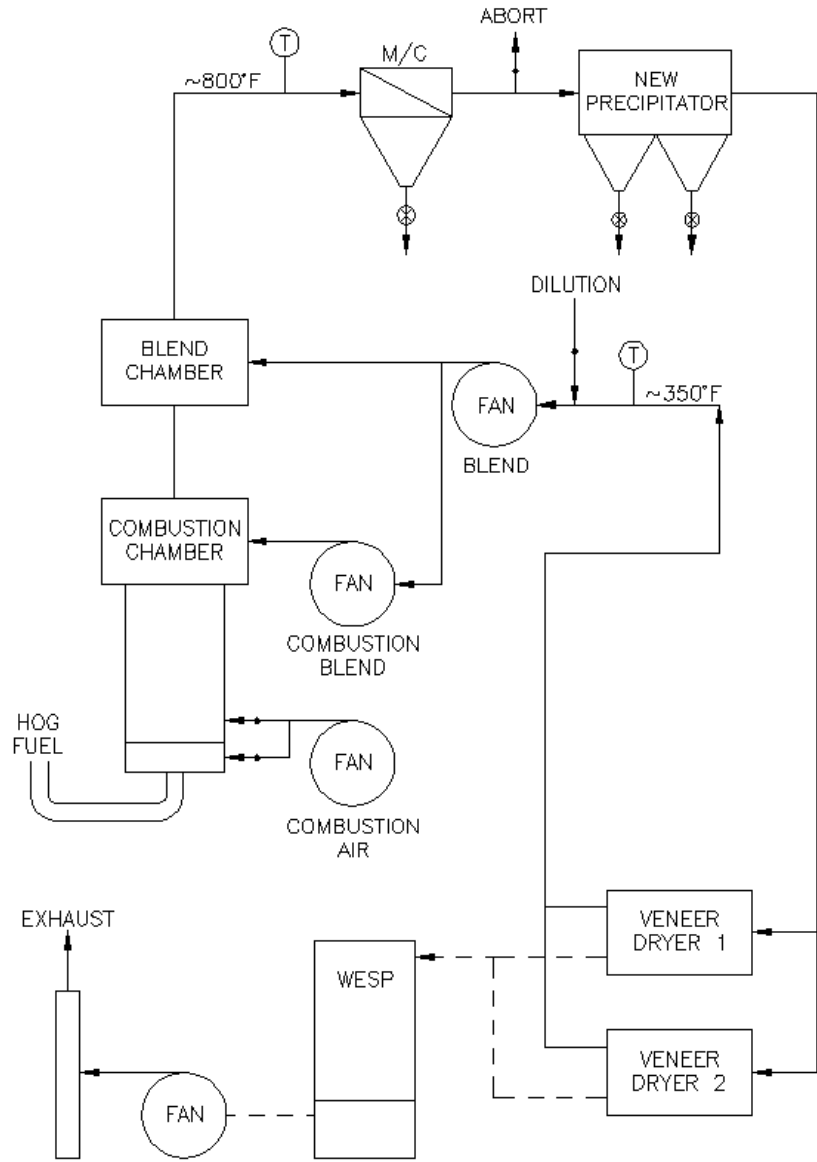
The electrostatic precipitator was modularized to minimize field erection time. The pieces were quite large and presented a real challenge to install them in the limited area. The electrostatic precipitator was so large, and the area for installation so small, several existing items had to be removed from the planned area. "Plum Creek even relocated the lunchroom."
